Filter Knowledge, Unfiltered

Diagnosing Engine Oil Filters With Collapsed Center Tubes

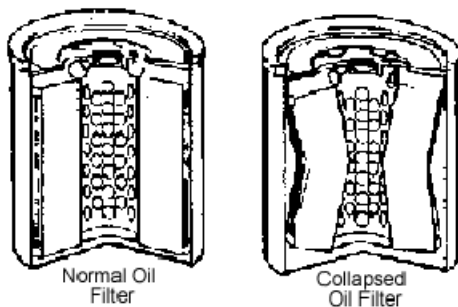
FIGURE 1

When a collapsed center tube or element is discovered, the natural tendency is to assume something is wrong with the filter (Fig. 1). This is not the case, but is a symptom of problems with internal engine components.

Therefore, when a center tube or element has collapsed, it is usually the result of a "sticking" or otherwise malfunctioning by-pass valve.

A collapsed center tube or element can lead to a loss of filtration and oil flow to the engine. There is the possibility that interior parts of the filter or filter media may be physically displaced and could migrate into the oiling system interfering with the oil flow.

An oil filter with a collapsed center tube or element indicates a malfunction within the system. Inspection of the system and a review of the engine's performance and maintenance history should be conducted.

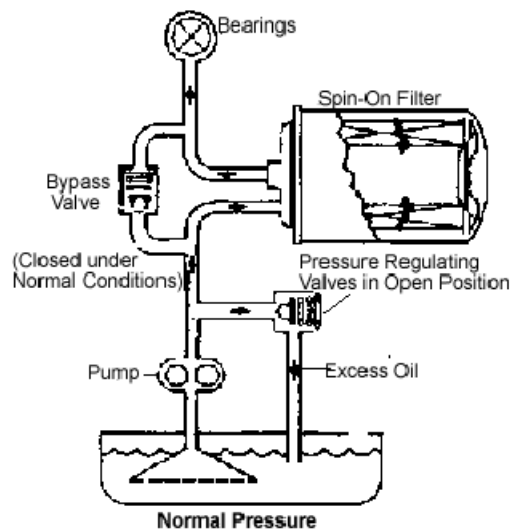
FIGURE 2

Most engines incorporate within the oiling system a by-pass valve across the inlet and outlet of the full flow oil filter. The valve is designed to open and by-pass oil around the filter and/or element when the restriction reaches its opening pressure (Fig. 2). The by-pass flow circuit insures oil flow to the engine when there is a significant restriction across the filter due to plugging or cold start conditions. Typically, engine manufacturers design by-pass valves to open at a pressure differential of approximately 10 to 30 psid with some as low as 4 psid (28 kPad), with some opening as high as 75 psid (500 kPad). Some engine manufacturers have the by-pass valve located in the filter mounting base on the engine, while others locate the valve in the filter. Either way, the same purpose is served.
